## Case Study – Bridge Monitoring

# Subway Bridge Bearing Misalignment

Central Europe

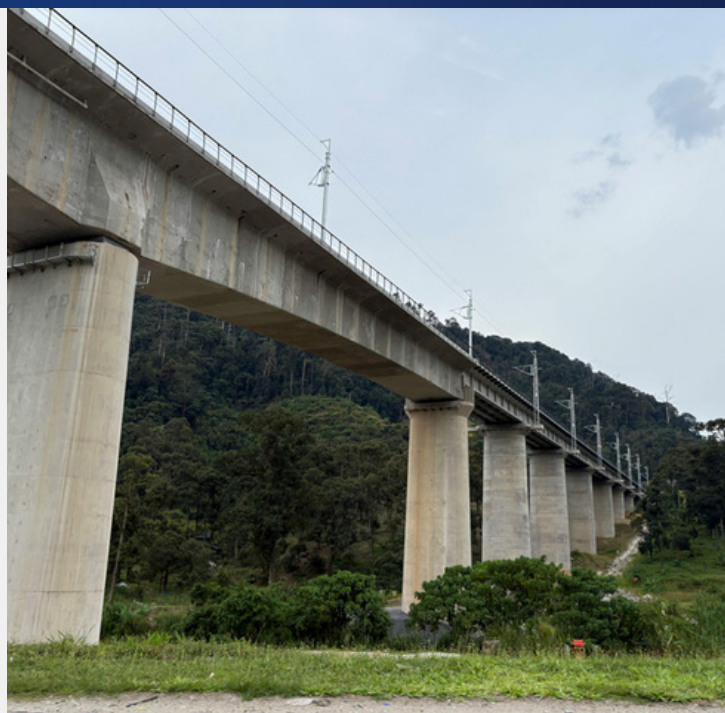
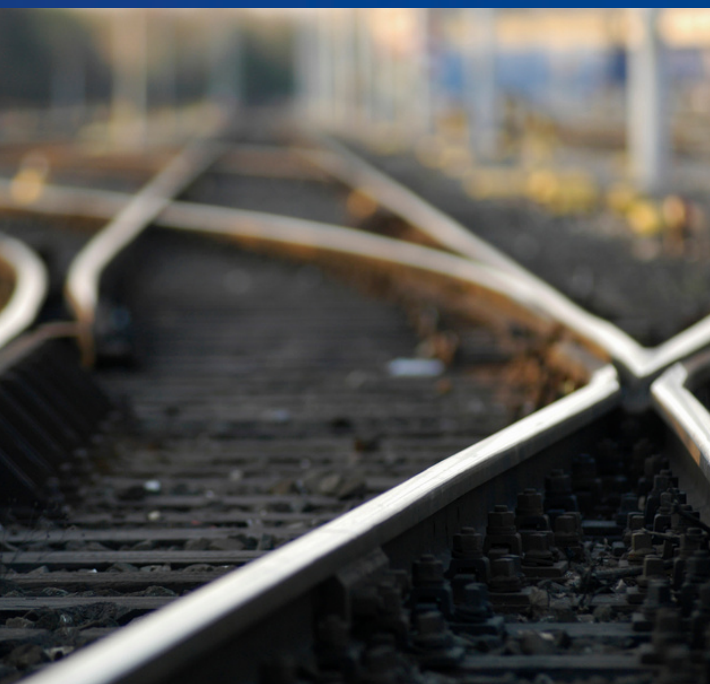
During a routine inspection of a metro bridge in Central Europe, significant misalignment and displacement of an elastomeric bearing were identified. As it was unclear how the damaged bearing would behave under continued operation and whether the observed deformations would worsen over time, the responsible authorities commissioned a measurement-based investigation.

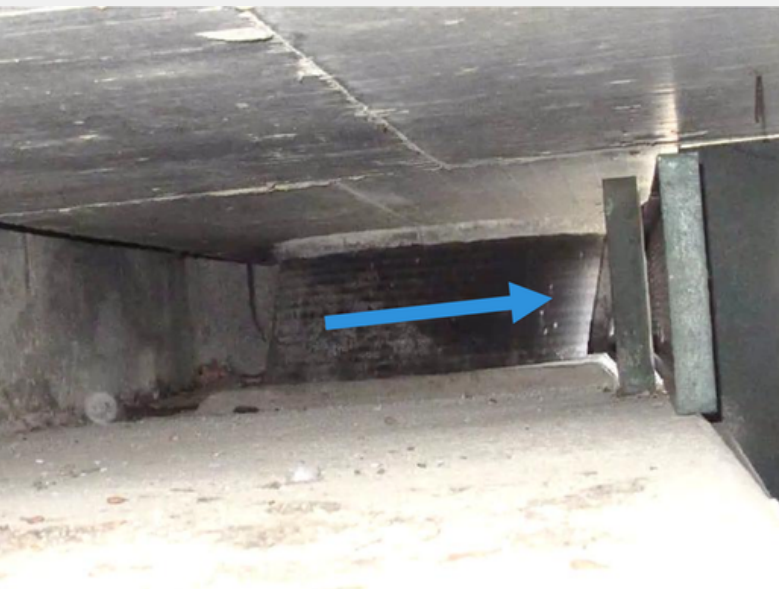
The measurements documented movements of up to 25 mm along the principal axis and displacements of up to 0.9 mm in the transverse direction. The analysis showed that the bearing misalignment remained stable and was strongly correlated with temperature. After a full seasonal cycle, the component consistently returned to its original position when the same temperature conditions occurred. This precise dataset provided evidence that no progressive deterioration was taking place. Based on the monitoring results, targeted measures were identified to maximise the remaining service life of the infrastructure.
