BRIDGE-MONITORING

Case study: bridge between Krems/Stein and Mautern NÖ

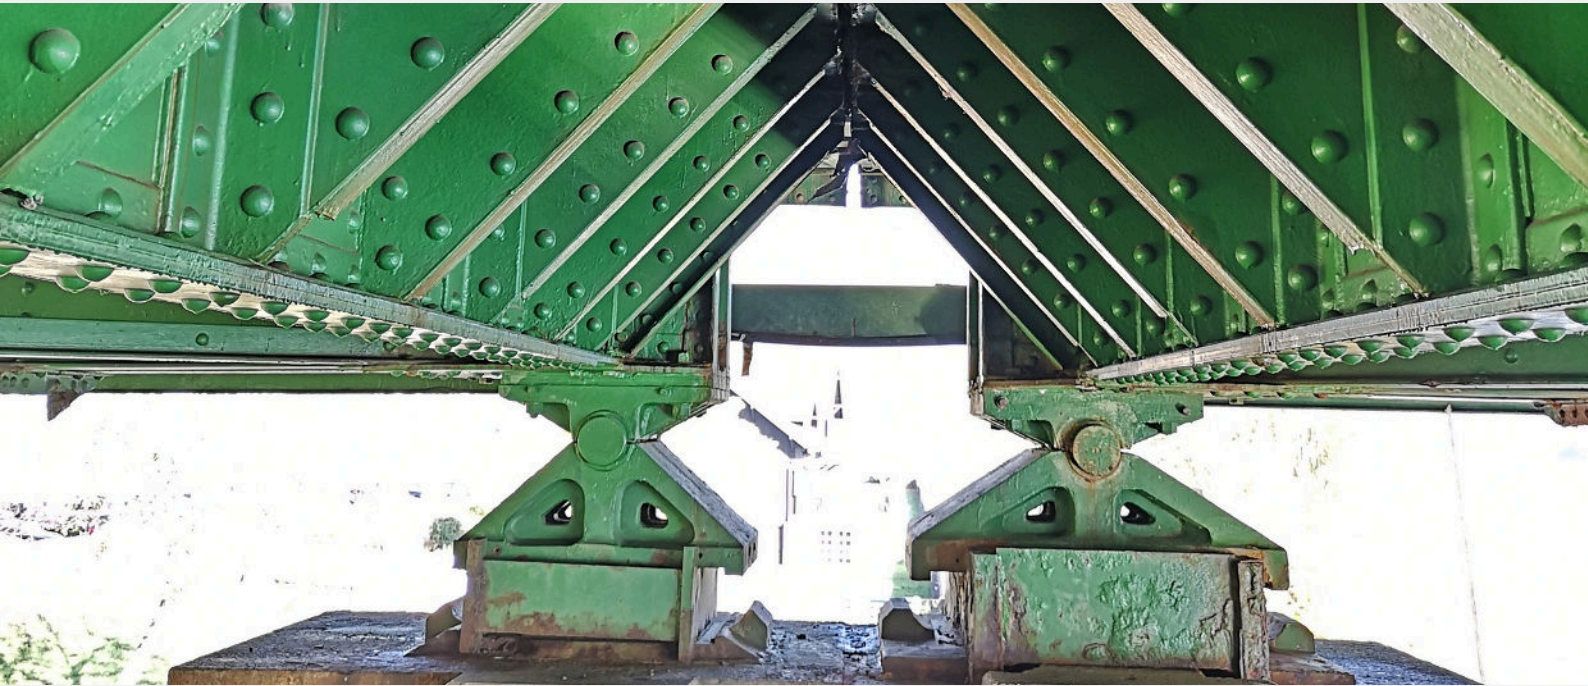
The Danube bridge in Lower Austria between Krems/Stein and Mautern is a historic steel bridge that requires renovation and maintenance work. The bridge is to remain in operation during the maintenance work; traffic will only be temporarily regulated on one side.

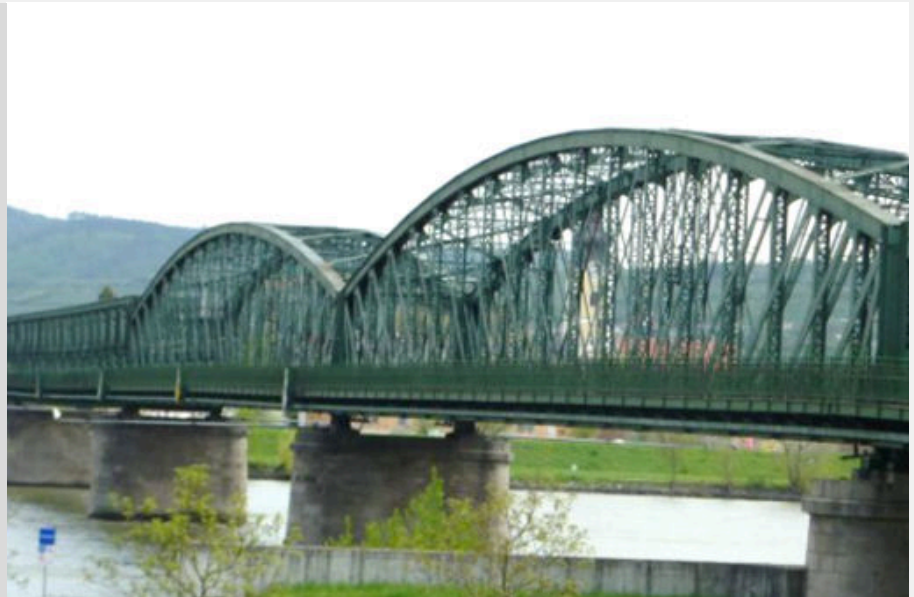
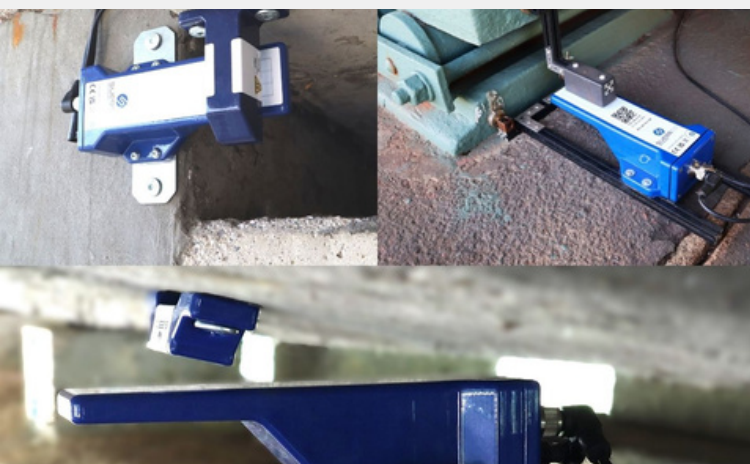
In addition to the age of the bridge, this maintenance work could potentially lead to critical situations. SuessCo was therefore commissioned to record the condition of the bridge and monitor it on an ongoing basis. This data will be used to document the safety of the bridge.

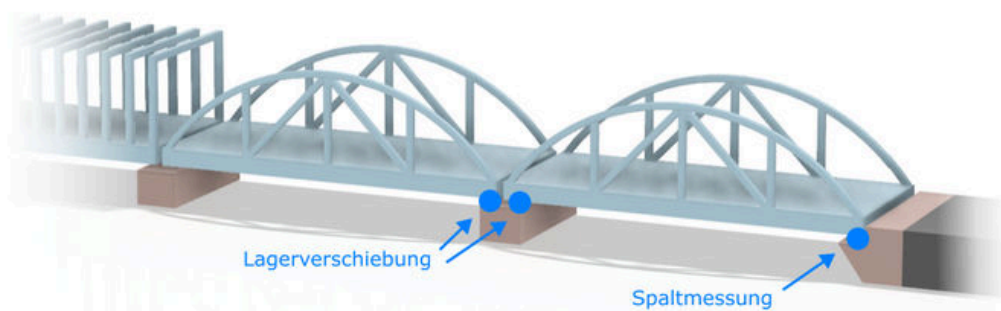
SuessCo 6D sensors for bearing displacement and gap measurements

The patented SuessCo 6D-sensor is the first and only sensor in the world that can measure 6 dimensions with just 1 structure. LTE-m data connection ensures the continuous transfer of data to the SuessCo monitoring portal. The results are correlated using special AI and clearly displayed in a graphical dashboard. The client therefore has up-to-date and precise data on the condition of the bridge from his desk at all times. The installation of the SuessCo sensors is uncomplicated and can be carried out by the customer himself. This also increases flexibility.

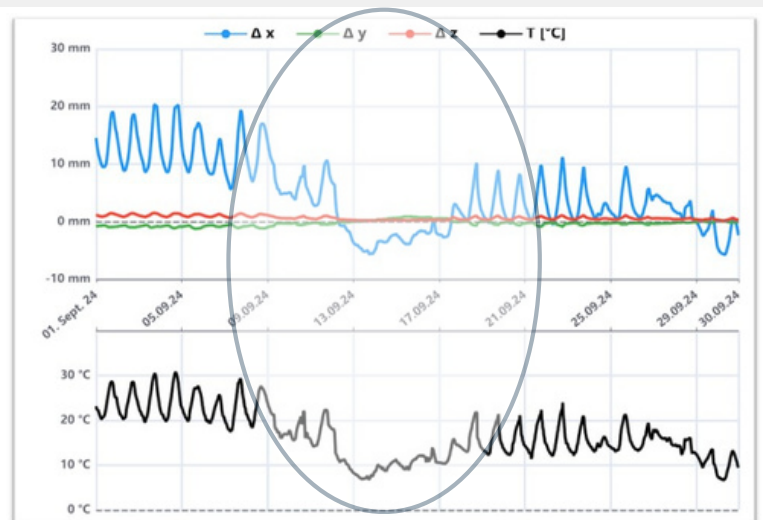
"The measurement data documents the flood situation in Lower Austria in September 2024. Due to the heavy rainfall, the structure temperature dropped noticeably and led to a shortening of the bridge segment by 15 mm. At the same time, the bridge pier was exposed to considerable flow forces. Subsequent measurements show a return to the usual diurnal cycle, which indicates the undisturbed function of the bridge bearing. The comparison with another sensor in the cross-section confirms that no displacement of the bearing took place. The bridge therefore remained safe for traffic during the entire period."
