# BRIDGE BEARING - MONITORING

## Case Study - ÖBB Hillside Bridge Lower Austria

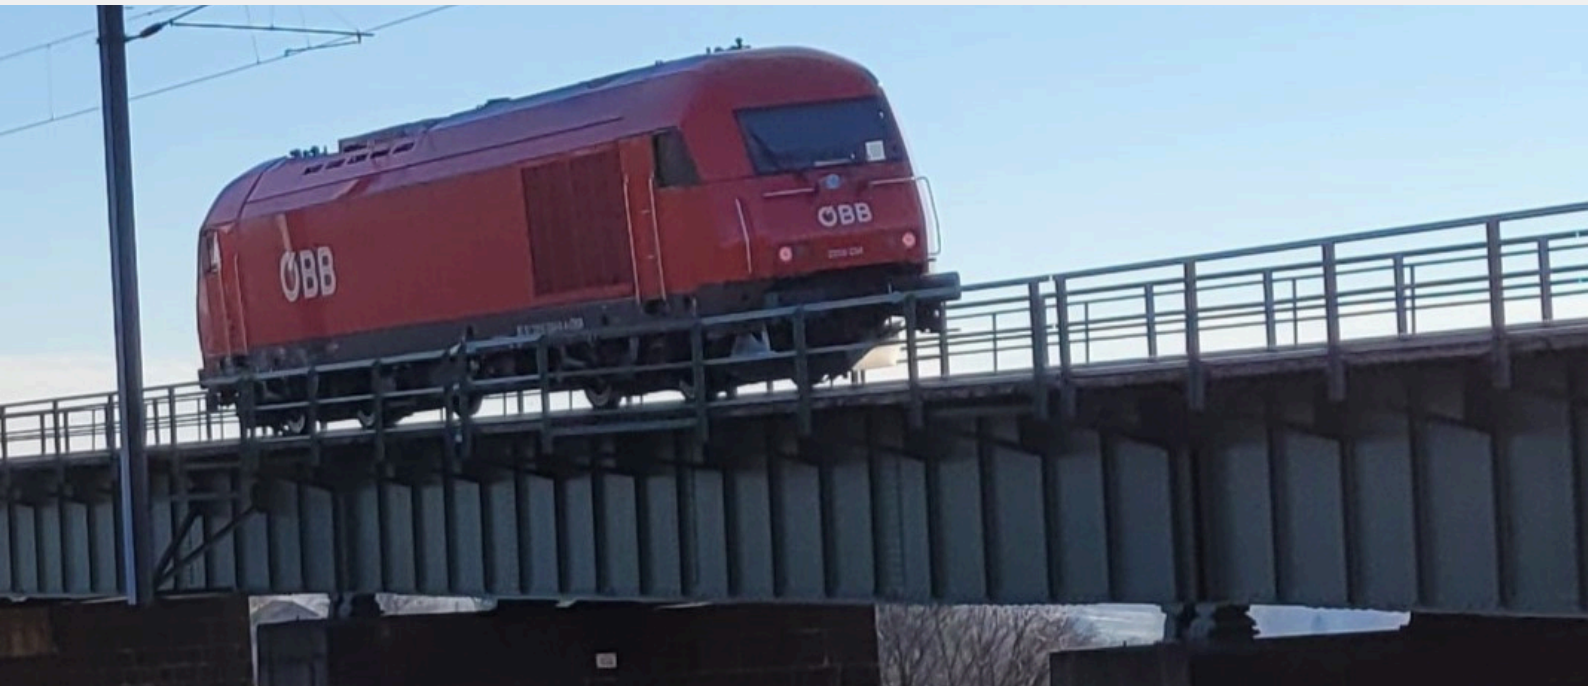
The more than 100-year-old bridge in Lower Austria is closely monitored by the ÖBB. Due to its hillside location, geological movements are suspected, but with the currently deployed methods, continuous monitoring of potential movements is not feasible.

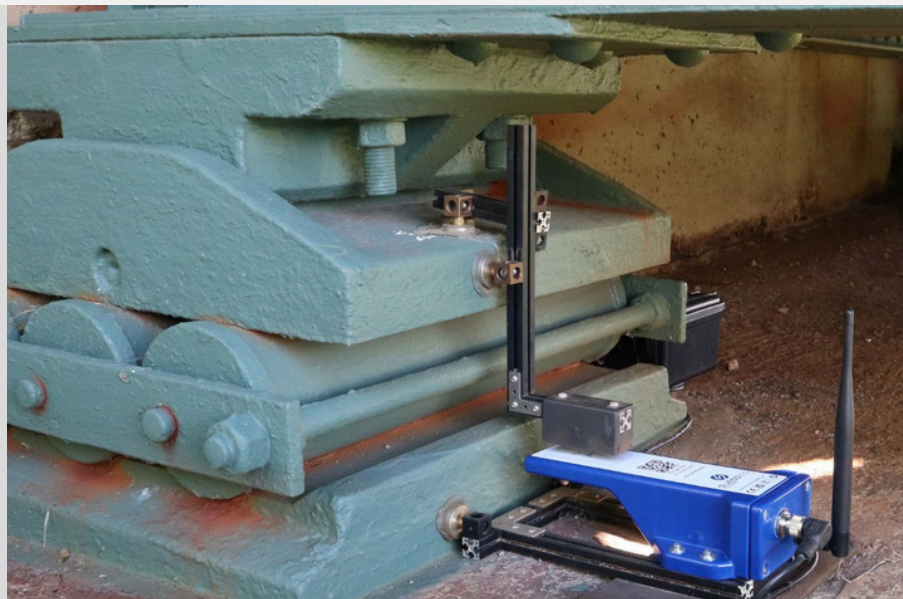
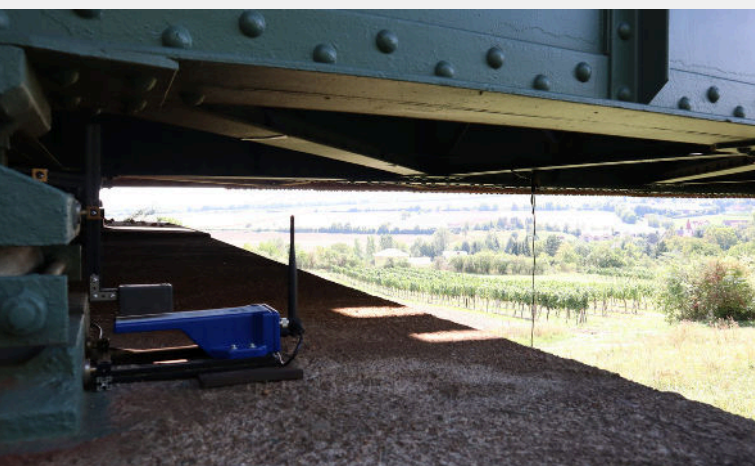
SuessCo 6D sensors were installed on the bridge bearings. Combined with data from the temperature sensors, the responsible individuals at ÖBB can now permanently monitor changes via a clearly organized dashboard from their desk.

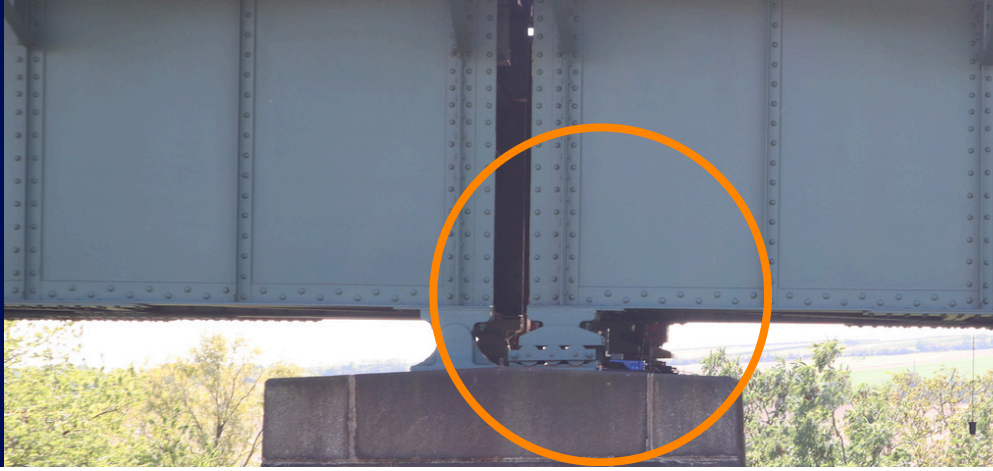
Data comparison over 3 years

The X-axis shows expected movements, while the Y and Z axes remain stable.
-

The "problem bearing" at the apex of the bridge shows shear movements (green).
-

Daily movement summary (mm)

Daily temperature summary (°C)

Daily temperature summary (°)
