# CRACK MONITORING

## Case Study - Residential building

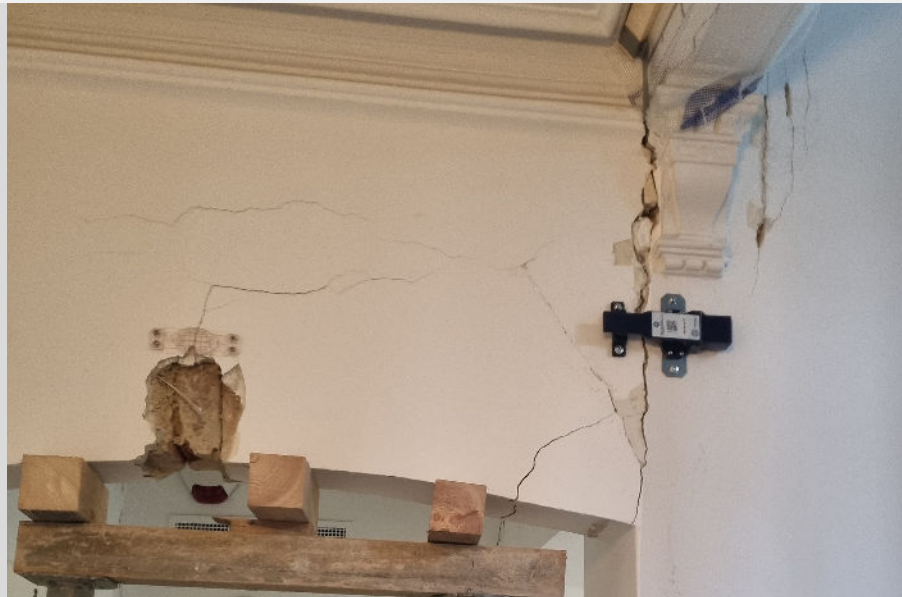
Years of construction work on a new subway line in the heart of a European metropolis have caused damage to a historic multi-story residential building. Tunnel excavation and the lowering of the groundwater level have led to subsidence in the subsoil, causing the building to tilt and cracks to form. These cracks, extending over multiple stories, are particularly evident at the junction between the old structure and a newer extension.
