## Case Study – Bridge Monitoring

# Danube Bridge

Lower Austria

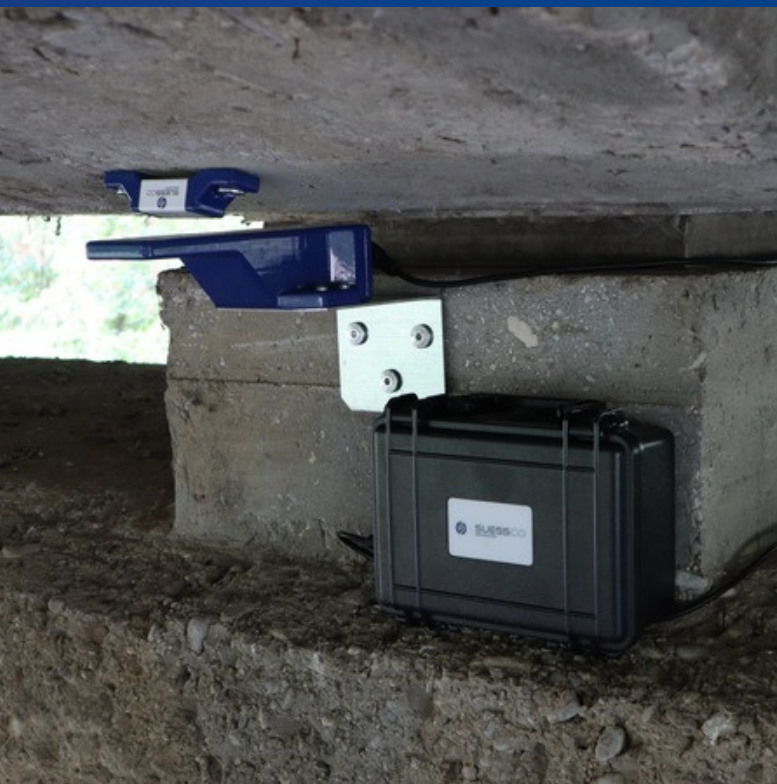
### SuessCo 6D Sensors for Bearing Displacement and Gap Measurements

A specially developed monitoring solution consisting of SuessCo 6D-Sensors installed at the bridge bearings and abutments, supplemented by temperature sensors, is deployed to continuously monitor structural movements, bridge temperatures, and environmental conditions.
