## Case Study – Bridge Bearing Monitoring

# ÖBB Hillside Bridge

Limberg, Austria

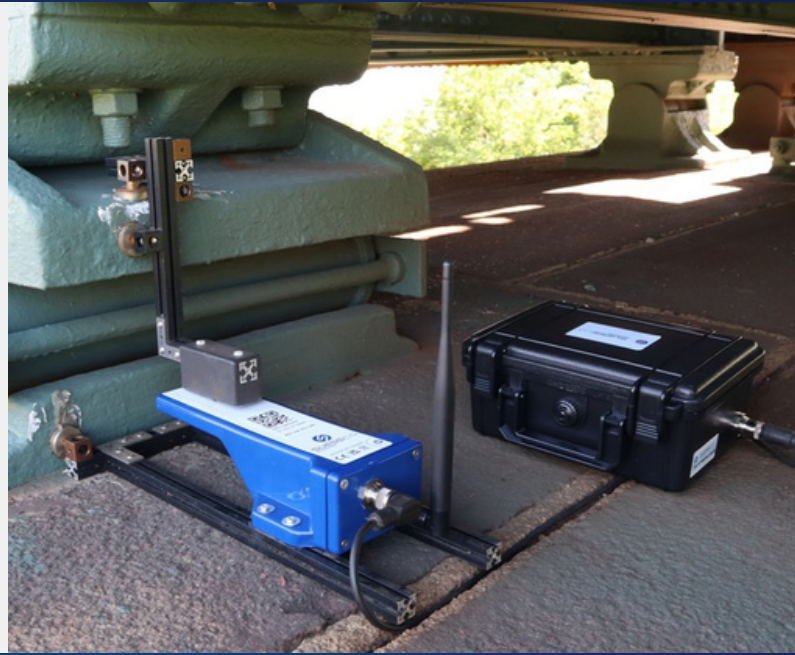
SuessCo 6D-Sensors were installed at the bridge bearings. Combined with data from the integrated temperature sensors, the responsible experts at ÖBB can now permanently monitor changes via a clearly structured dashboard from their desks.
