## Case Study – Bridge Monitoring

# Subway Bridge Bearing Misalignment

Central Europe

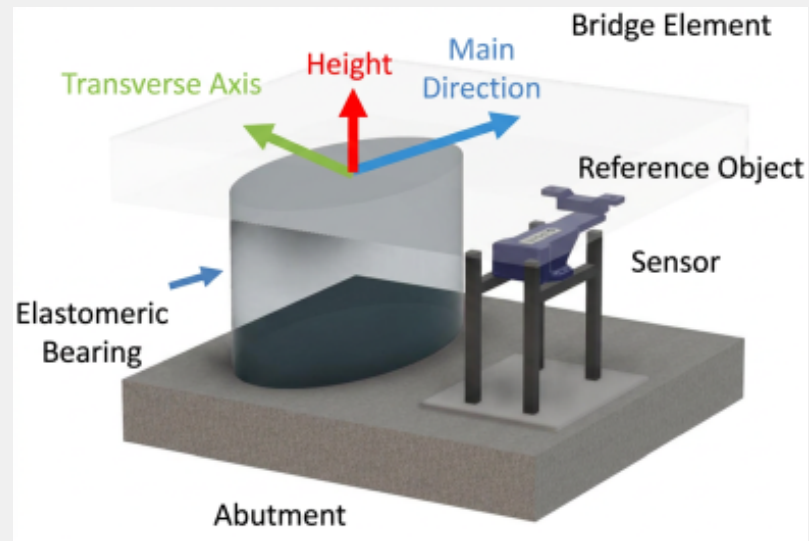
To meet these requirements, the bridge was equipped with SuessCo 6D-Sensors in the area of the affected bearings. Over a period of one year, the sensors continuously recorded three-dimensional movements together with temperature data. This long-term monitoring provided a comprehensive dataset, enabling the structural response to thermal effects to be analysed throughout the complete seasonal cycle.

The measurements documented movements of up to 25 mm along the principal axis and displacements of up to 0.9 mm in the transverse direction. The analysis showed that the bearing misalignment remained stable and was strongly correlated with temperature. After a full seasonal cycle, the component consistently returned to its original position when the same temperature conditions occurred. This precise dataset provided evidence that no progressive deterioration was taking place. Based on the monitoring results, targeted measures were identified to maximise the remaining service life of the infrastructure.
