## Case Study – Bridge Monitoring

# Flood Event Road Bridge

Central Europe

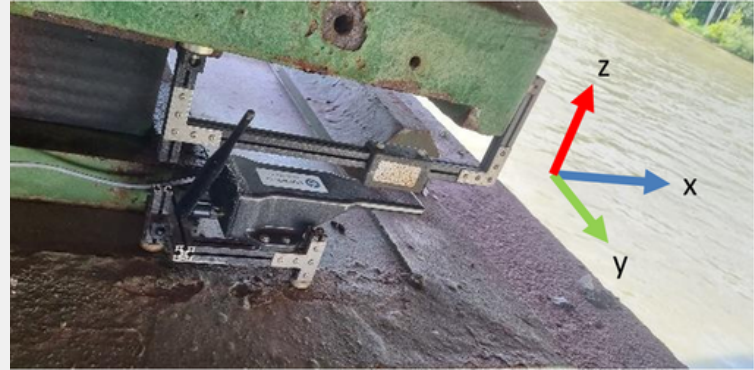
The steel bridge was equipped with high-precision 6D-Sensors from SUESSCO Sensors. The measurement setup included monitoring of the bridge bearings as well as precise gap measurement at the abutment. For long-term monitoring, strategically selected bridge bearings were equipped with sensors to continuously capture movements in all degrees of freedom, as well as inclination and temperature, directly at the structure.

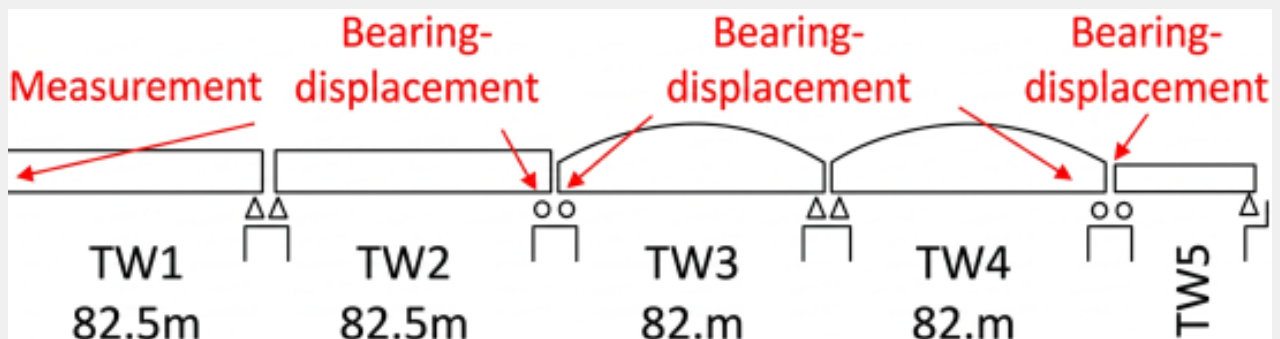
During an extreme flood event, the system transmitted structural data in real time for immediate situational assessment. The sensors registered two days of extreme movements equivalent to many months of normal activity. However, analysis revealed that these were purely thermally induced by a simultaneous temperature drop; as temperatures rose again, the structure returned fully to its original state. The water pressure caused no permanent damage, allowing the operator to avoid a precautionary closure. In the long term, the project delivers valuable insights into the resilience and maintenance cycles of ageing infrastructure, thereby optimising strategic asset management.
